# FIRST NATIONAL BANK

131 Main Street | Ottumwa, Iowa

## Historic Structure Report

December 2021

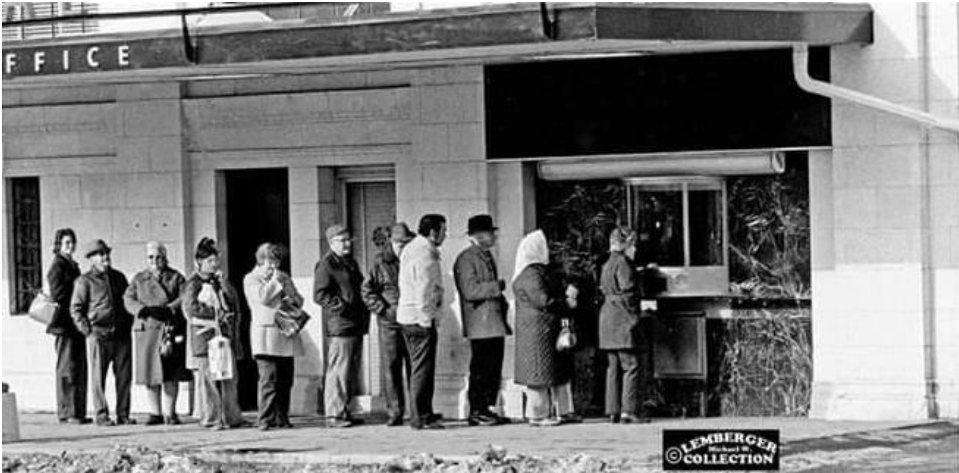
Figure 16: Walk-up teller window and metal awning were removed at an unknown date. Photo date unknown, likely 1970's.

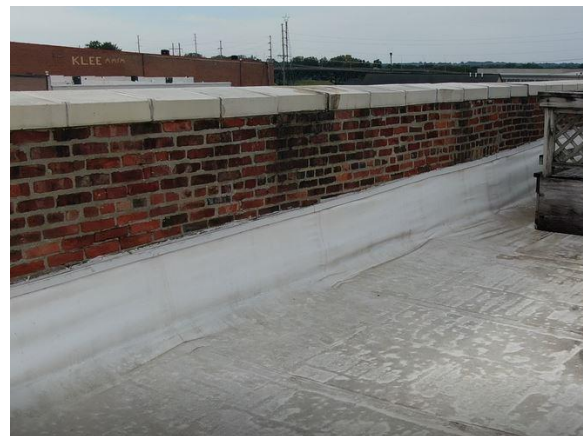
The inside face of the parapet wall to the northwest appears to have a cement stucco finish. The stucco appears to be in fair condition with some cracks and spalling. The wall coping is prefinished metal. This may be a party wall with the adjacent building.

**Figure 45:** Back of parapet wall, view southeast. Sept. 2021.

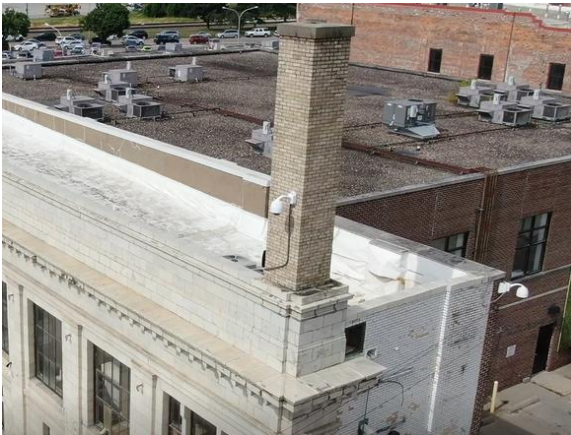
The chimney is located at the east corner of the building. This is clad in tan colored face brick. The bricks appear to be in fair condition, generally. About 10% have experienced spalling or cracking.

**Figure 46:** Chimney at north end of building, view southwest. Sept. 2021.

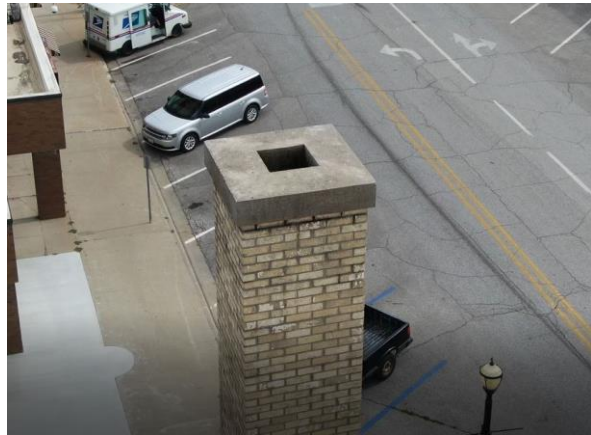
The cap is cast concrete; the cap appears to be in good condition.

**Figure 47:** Chimney cap. Sept. 2021.

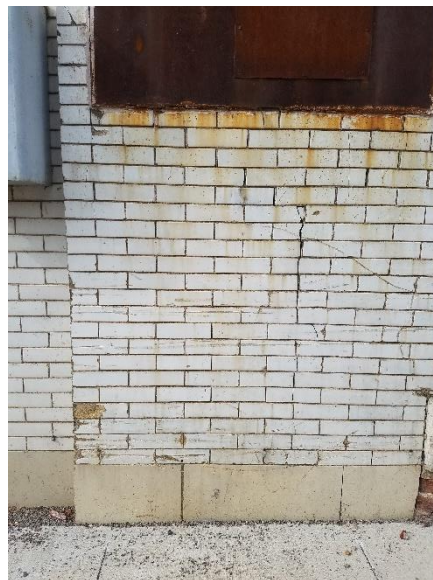
Most of the areas exhibited moderate to severe damage of the glazed brick. Damage included surface spalling. A few of the areas exhibited surface staining.

**Figure 53:** Typical conditions of glazed brick at alley elevation. North elevation. Sept 2021.

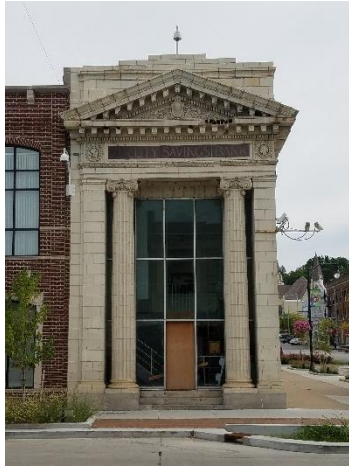
The main entrance has a two-story aluminum framed single glazed storefront system. This dates from the time of the bank remodeling. Aluminum is clear coat in color. The door is missing at this location. The door appears to have had an in-floor door closer.

**Figure 57:** Non-original storefront system. South elevation. Sept. 2021.

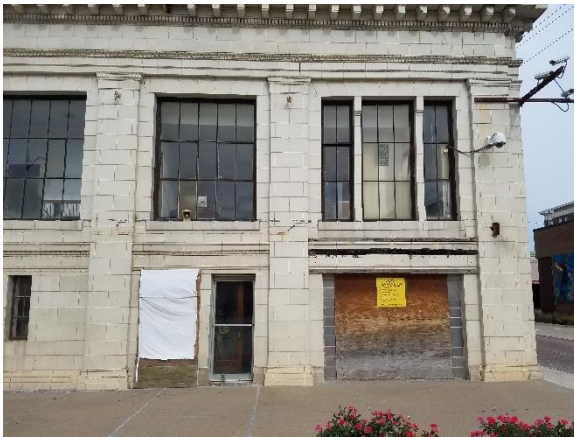
First floor windows are single glazed, steel framed. Most have considerable surface rust but appear to be in fair condition. Several also have a security grille. Some glass has been replaced with plexiglass.

**Figure 59:** Typical window and door conditions. East elevation. Sept. 2021.

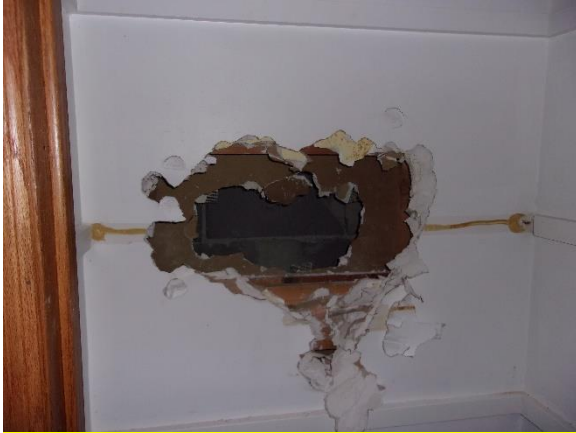
**Figure 69:** Wall damage (likely selective demolition) at first floor. Sept. 2021.

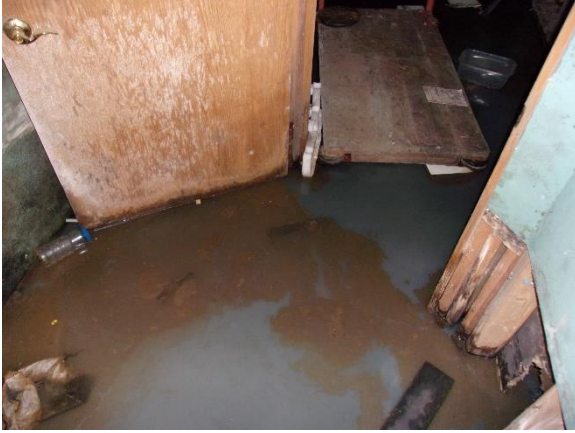
The floors in the basement were generally unavailable for observation due to the water found there, but are likely concrete.

**Figure 73:** Typical conditions at basement. Sept. 2021.

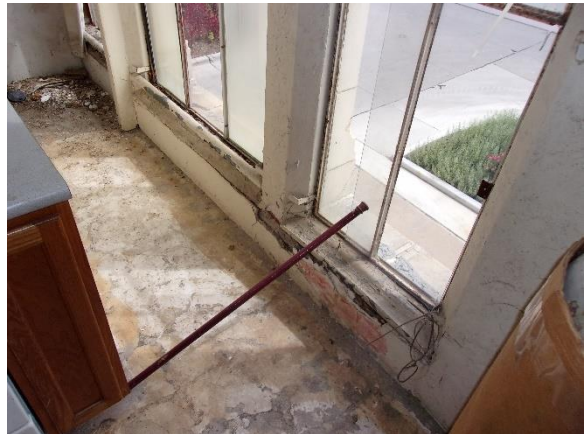
At the second floor, floors appear to be solid and in good condition. Floors are built of bar joist and metal deck with a concrete topping slab. This floor does not appear to be original; the bar joist and metal deck appear to be newer than 1931. Carpeting is principally used at this level but some areas have had the carpeting removed, revealing the subfloor below.

**Figure 78:** Exposed sub-flooring at second floor. Sept. 2021.

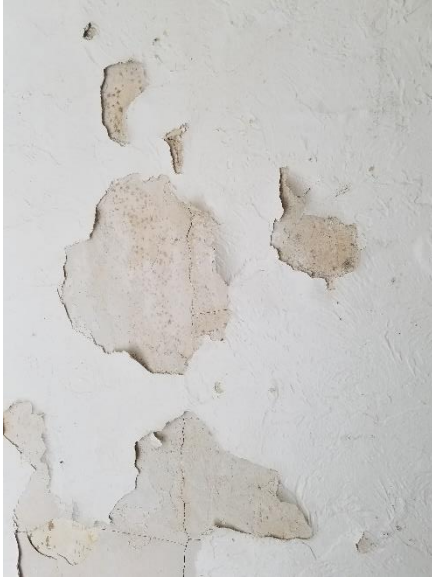
Interior finishes are in fair to poor condition. Some original materials remain (such as marble wainscoting and plaster finishes). Some areas are more deteriorated than others due to the building being vacant and interior temperatures not being maintained.

Figure 87: Peeling paint conditions at first floor. Sept. 2021.

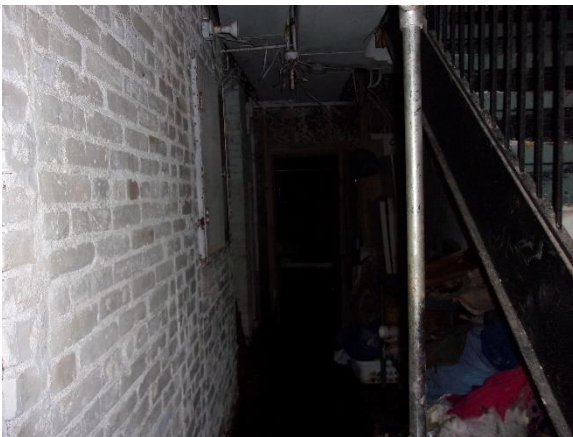
Water in the basement prevented a thorough investigation of the foundation. That available for viewing appears to be structurally sound but has a lot of surface cracking and spalling. Gray granite is used on the exterior of the building; interior walls are brick.

Figure 97: Basement foundation wall. Sept. 2021.

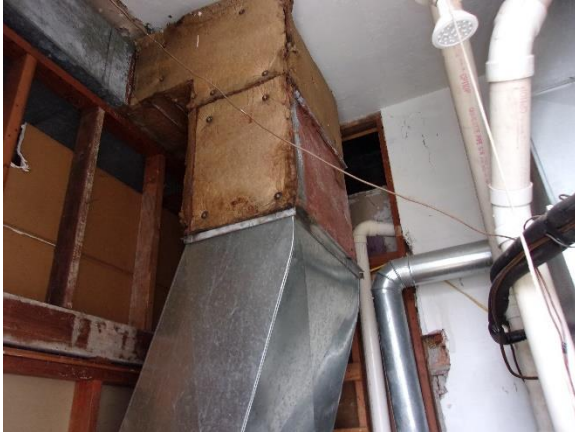
- The HVAC equipment in the basement is completely ruined from water damage, and
- The dirt/dust in the ductwork has substantial mold build-up

**Figure 98:** Mechanical ducts, second floor. Sept. 2021.

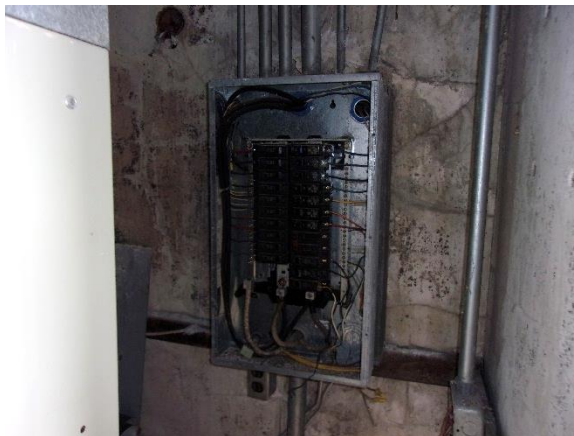
The electrical feed coming from the transformer to the building has been disconnected at the building exterior. There are no live conductors entering the building. The existing Main Distribution Panel (MDP) is located in the basement. At the time of the site visit this area was not accessible but the MDP is assumed to be past its useful life and assumed water damage along the cabling to and from the panel. There are a few sub-panels scattered throughout the building, these panels are outdated and past their useful life.

Figure 103: Electrical panel.
