# FIRST NATIONAL BANK

131 Main Street | Ottumwa, Iowa

## Historic Structure Report

December 2021

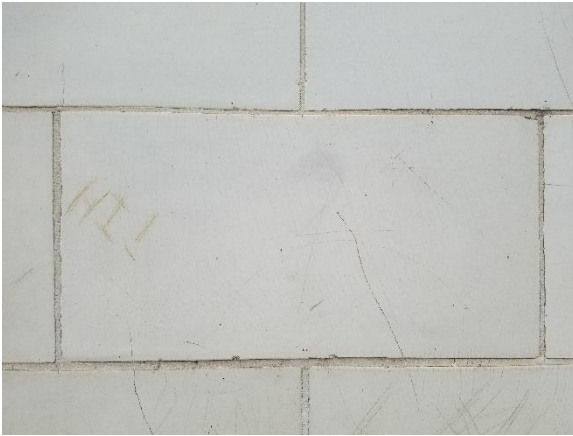
**Figure 25:** Terra cotta clad exterior walls, east elevation. Sept. 2021

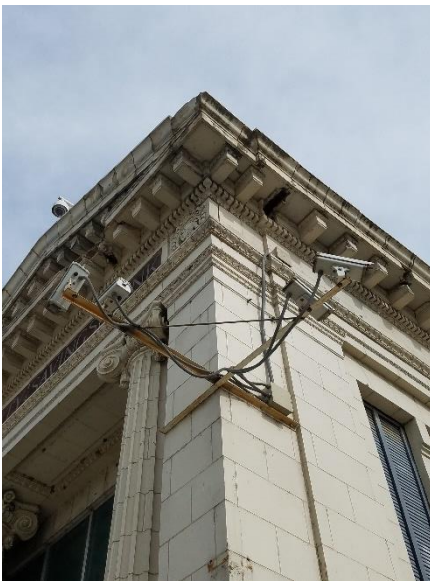
**Figure 27:** Terra cotta details at cornice, view northwest. Sept. 2021

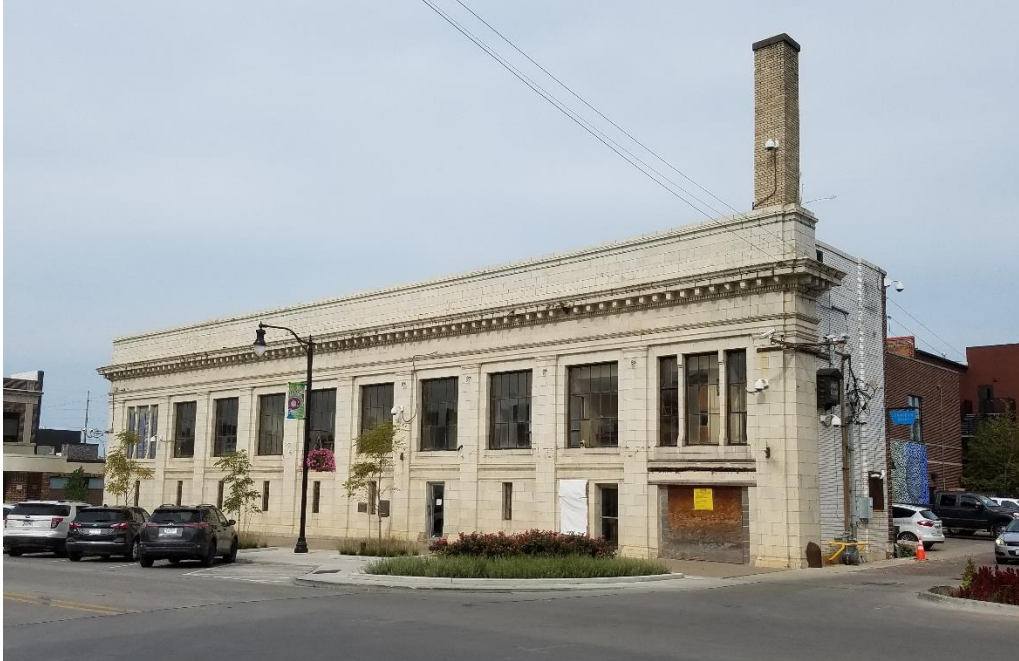
Figure 36: Overall east elevation. September 2021.

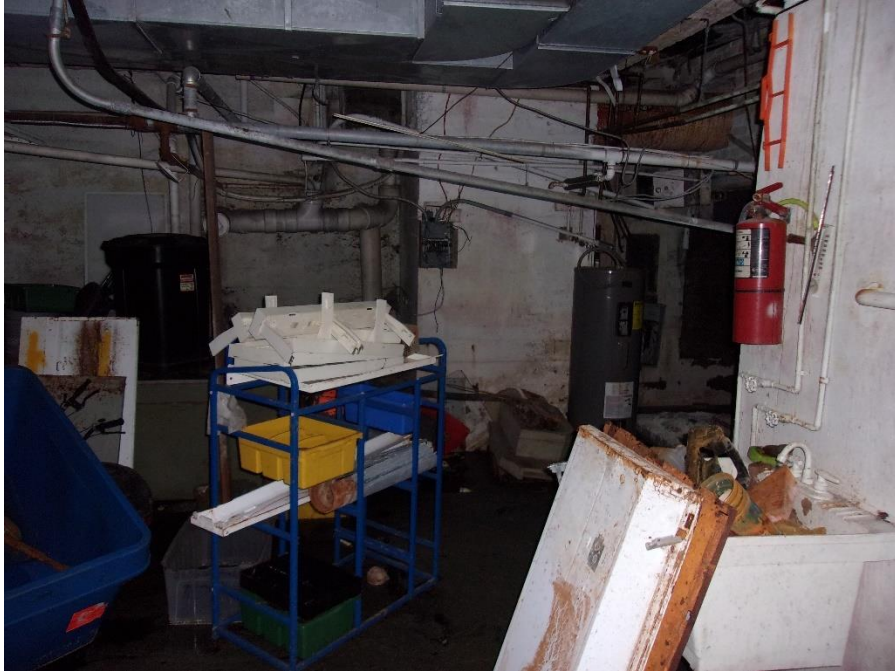
Figure 38: Typical basement conditions. September 2021.

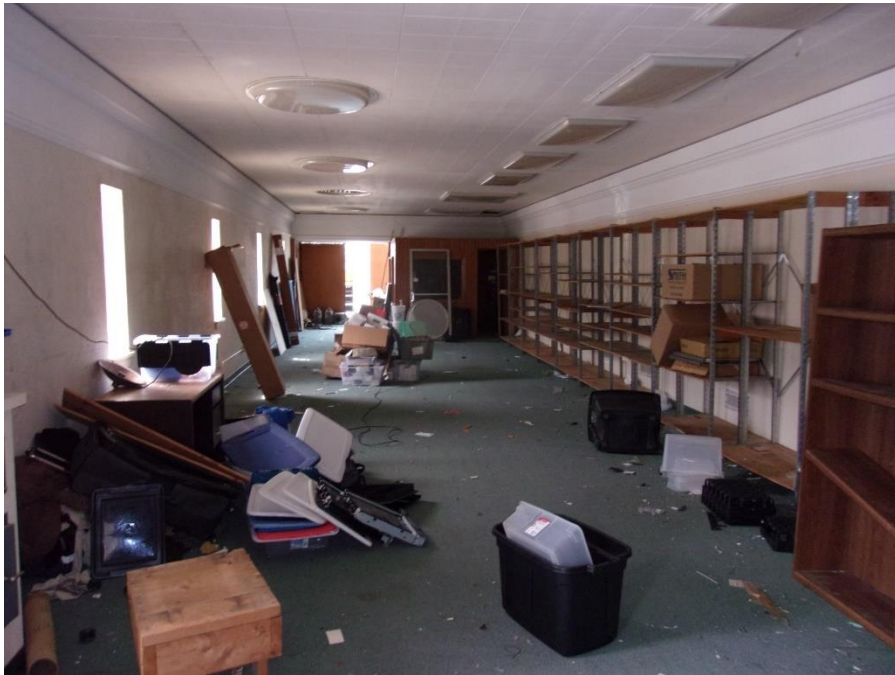
Figure 39: Overall view of first floor, view south. September 2021.

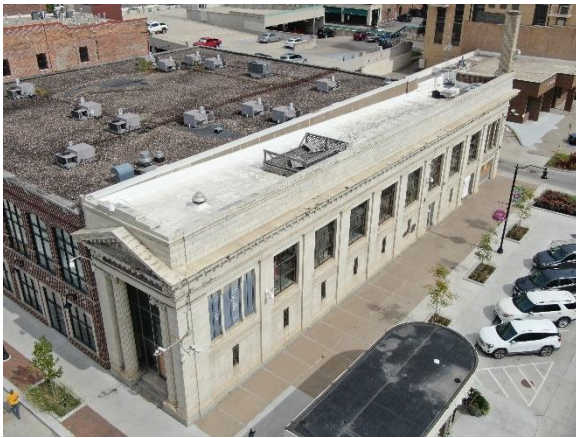
Current roof is reinforced concrete with white rubber membrane. The membrane appears to be in good condition. The membrane extends up the inside face of the parapet walls about two feet. There is some concern with the parapet around the perimeter as well as the cornice stone. The parapet has sealed joints where the sealant is damaged or missing. The cornice stone is in poor condition as it is cracked, missing and appears to be completely failing on the south façade. No significant

**Figure 42:** View of roof, view northwest. Sept. 2021.

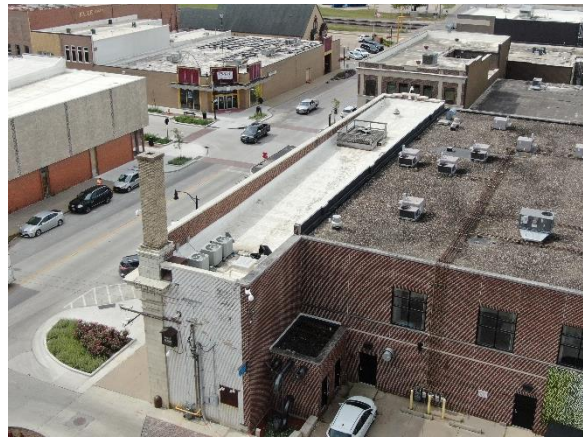
**Figure 43:** View of roof, view southeast. Sept. 2021.

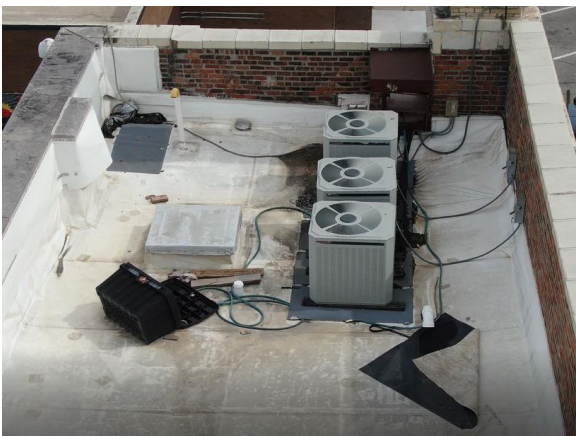
**Figure 44:** Mechanical units on roof, view south. Sept. 2021.

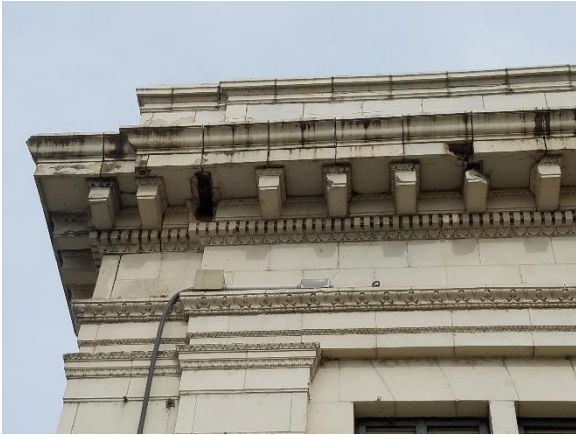
Several areas exhibited moderate to severe damage of the terra cotta. Damage included missing or partially missing pieces, surface spalling, and cracked masonry. A few of the areas exhibited surface staining.

**Figure 50:** Typical cornice detail, east elevation. View west. Sept. 2021.

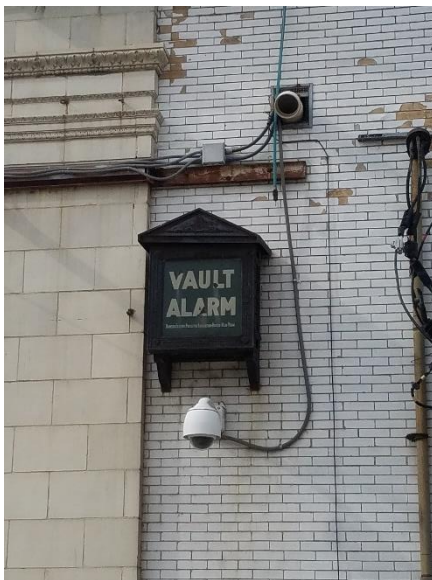
**Figure 52:** Vault alarm located on alley elevation. North elevation. Sept 2021.

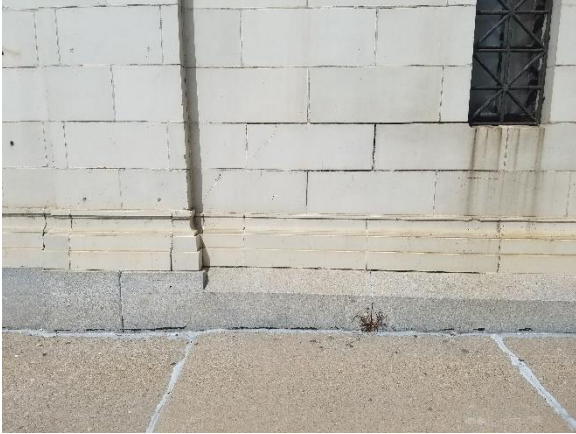
The base of the walls has a gray granite cladding; this was likely used to mitigate impact to the terra cotta cladding.

**Figure 54:** Typical condition of foundation wall, gray granite. East elevation. Sept 2021.

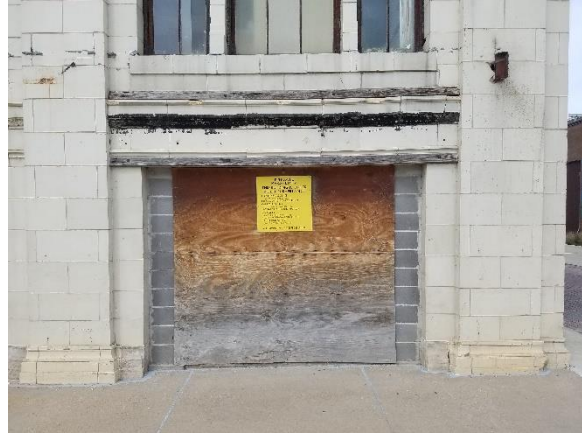
**Figure 55:** Typical condition of foundation wall at openings, gray limestone. Sept 2021.

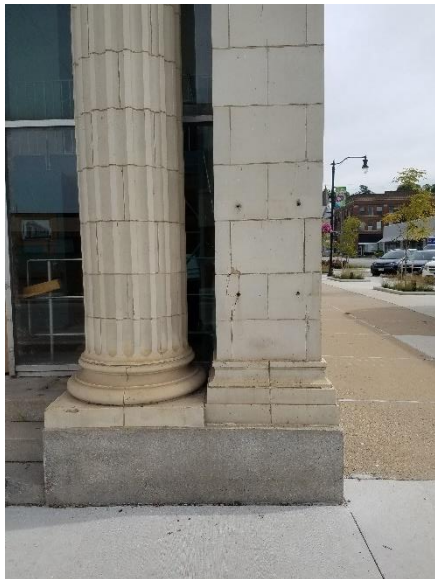
**Figure 56:** Typical condition of foundation wall, gray granite. South elevation. Sept 2021.

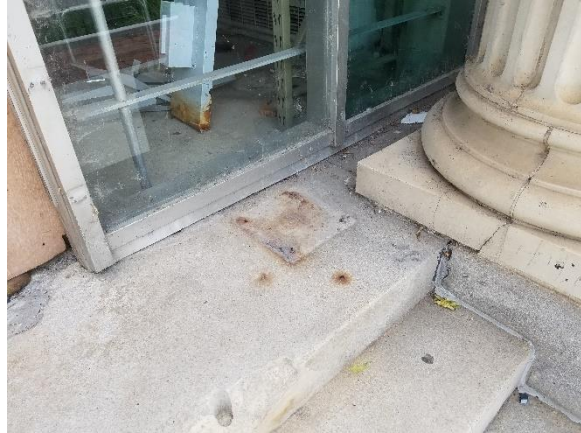
The main entrance has a two-story aluminum framed single glazed storefront system. This dates from the time of the bank remodeling. Aluminum is clear coat in color. The door is missing at this location. The door appears to have had an in-floor door closer.

**Figure 58:** Storefront condition and main entrance. View northeast. Sept. 2021.

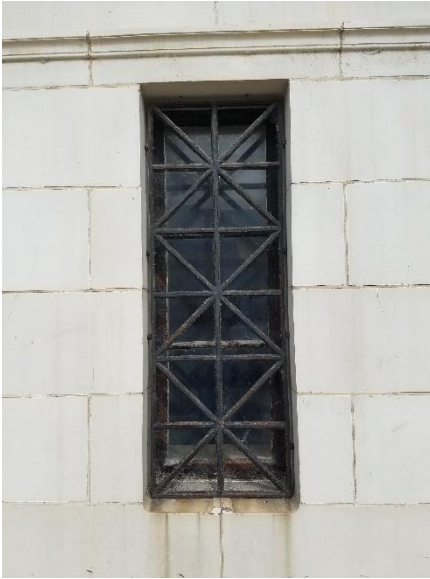
First floor windows are single glazed, steel framed. Most have considerable surface rust but appear to be in fair condition. Several also have a security grille. Some glass has been replaced with plexiglass.

**Figure 61:** Typical first floor window, with security grille. East elevation. Sept. 2021.

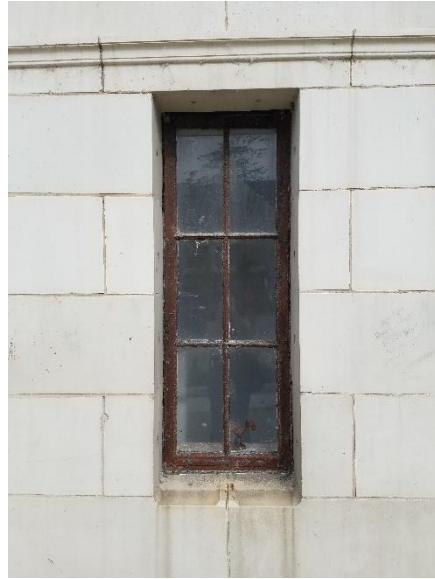
**Figure 62:** Typical first floor window, without security grille. East elevation. Sept. 2021.

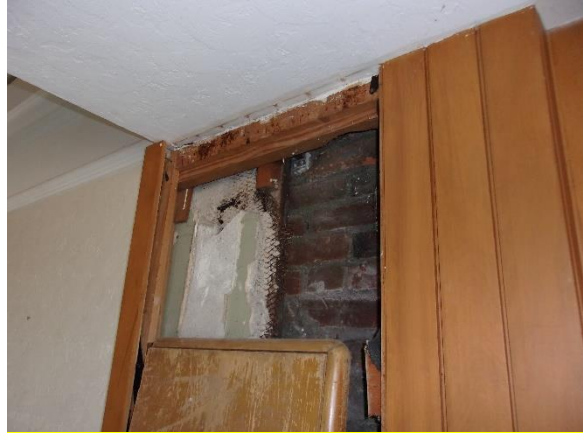
**Figure 70:** Structural brick wall exposed behind finished walls at first floor at east wall. Sept. 2021.

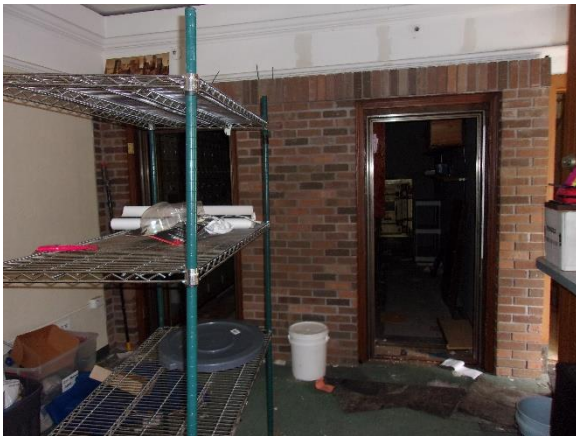
**Figure 71:** Brick veneer accent wall (not original), view north. Sept. 2021.

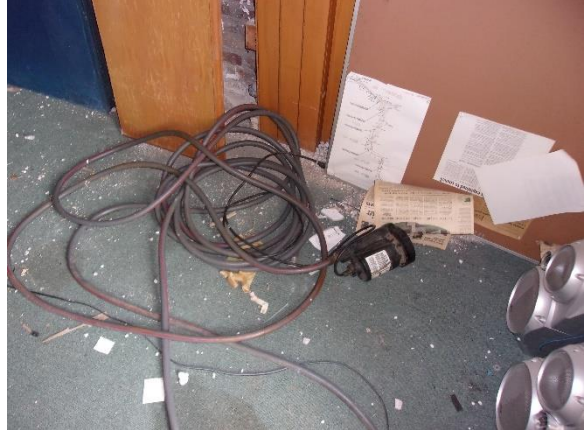
**Figure 74:** Carpet at first floor, typical conditions. Sept. 2021.

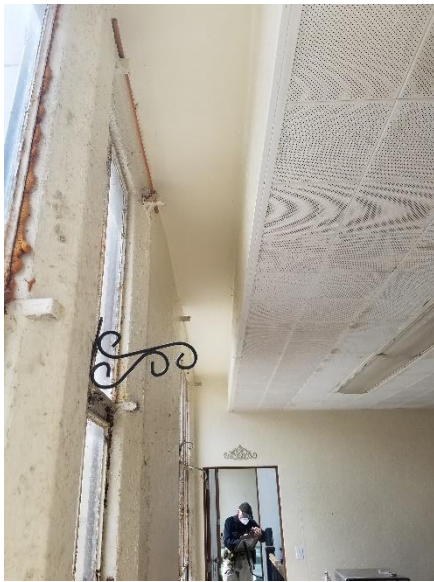
**Figure 84:** Second floor dropped ceiling set back to maintain original window openings. Sept. 2021.

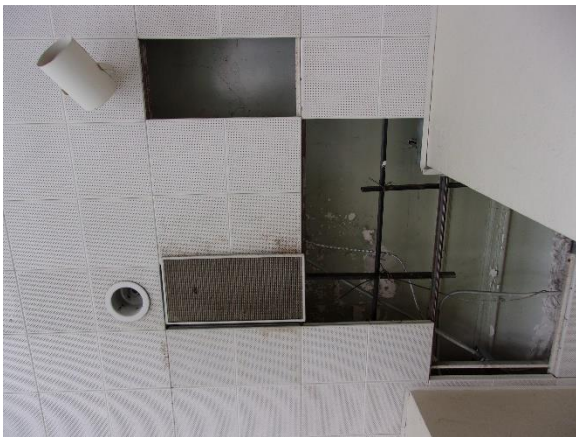
**Figure 86:** Original ceiling exposed above dropped ceiling at south entry. Sept. 2021.

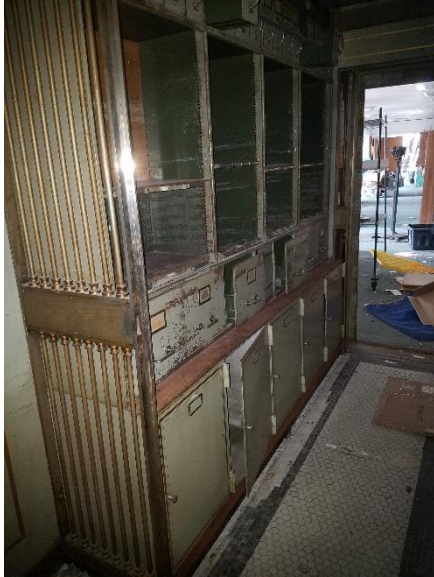
Figure 91: Vault furnishings, first floor. Sept. 2021.

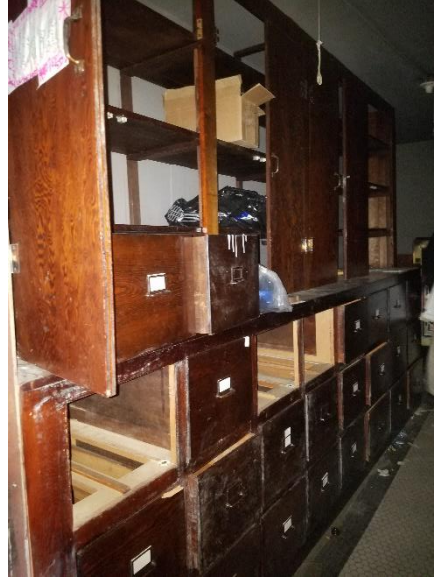
Figure 92: Vault furnishings, first floor. Sept. 2021.

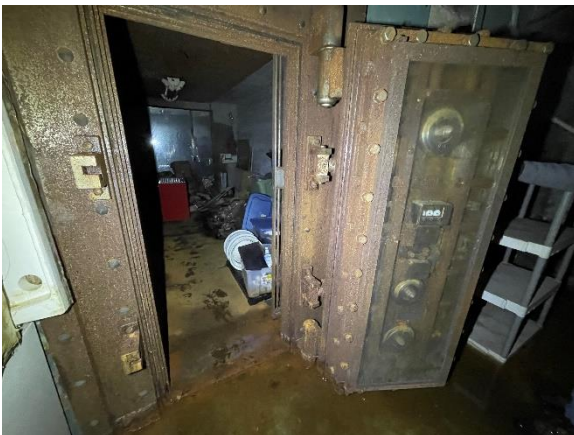
Water in the basement prevented a thorough investigation. The basement extends the full length of the building, extending east below the public right of way (sidewalk). Two vaults are located in the basement, one located under the first floor vaults and a second one on the west side, near the middle of the building.

Figure 93: Vault at basement level.

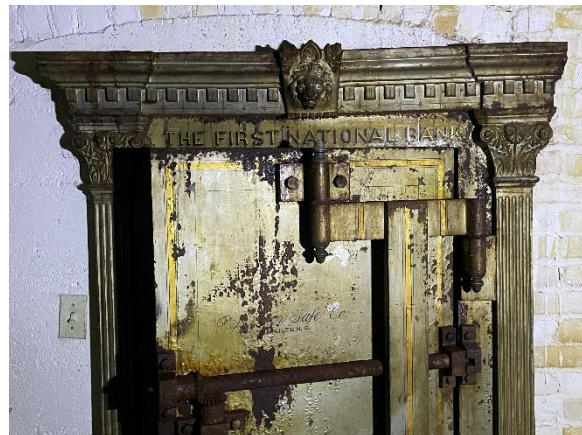
Figure 94: Vault at basement level.

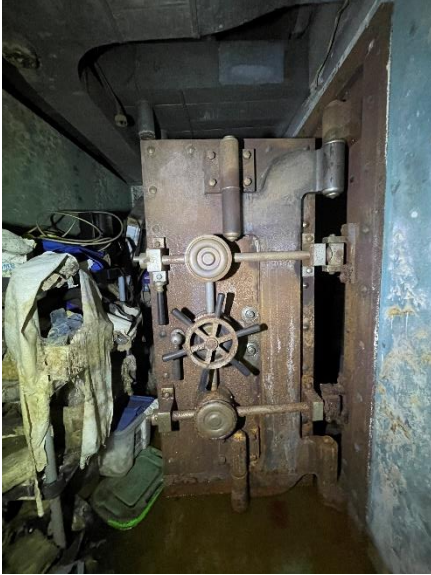
Figure 95: Vault at basement level.

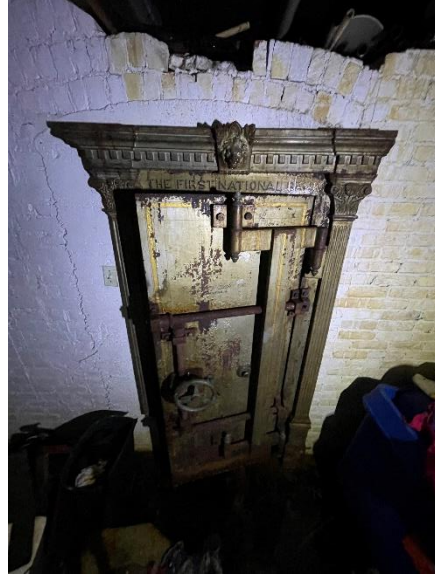
Figure 96: Vault at basement level.

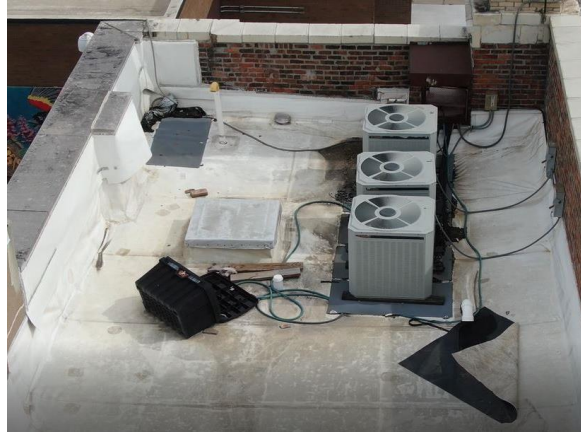
**Figure 100:** Rooftop units. Sept. 2021.

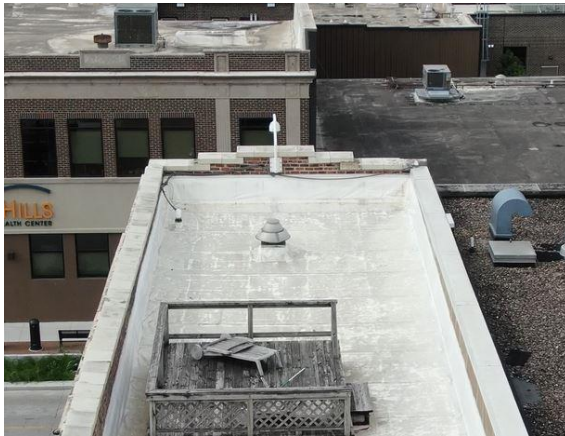
**Figure 99:** Rooftop vents. Sept. 2021.

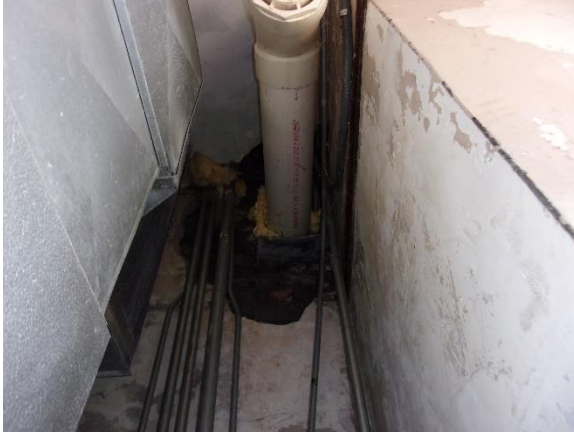
Figure 101: Plumbing pipes at second floor.

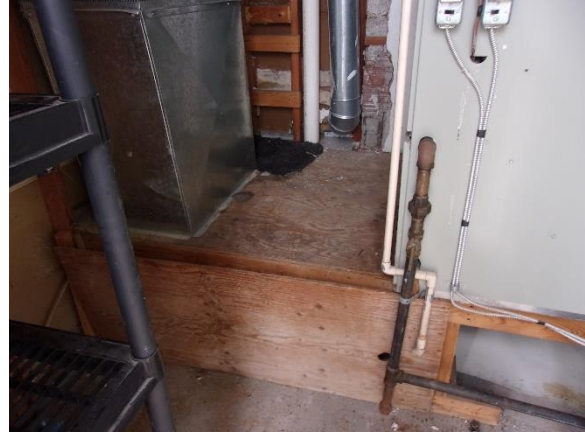
Figure 102: Plumbing pipes at second floor.

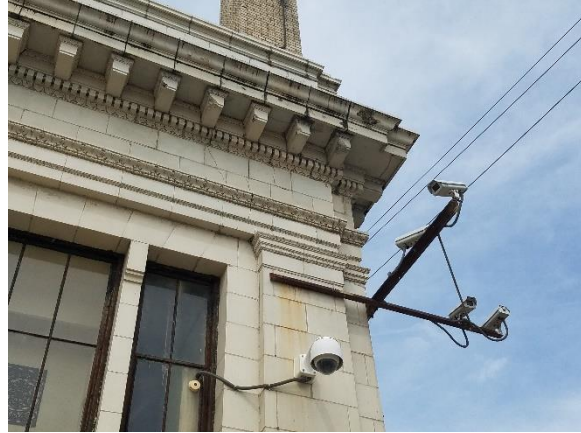
**Figure 105:** Security cameras at northeast corner. Sept. 2021.

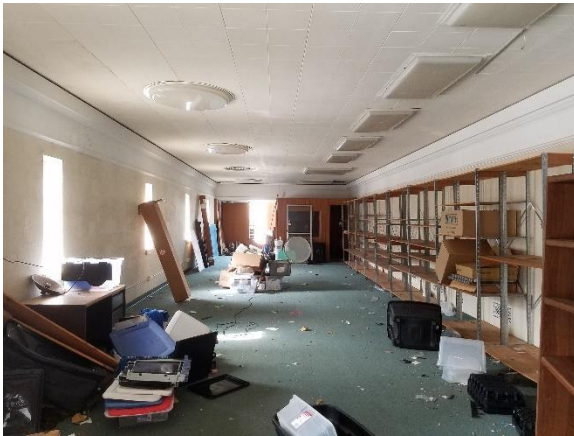
No original lighting fixtures exist. The existing lighting is all halogen, fluorescent tube or incandescent. The existing lighting controls are all manual on/off toggle type switches.

**Figure 106:** Lighting at first floor. Sept. 2021.

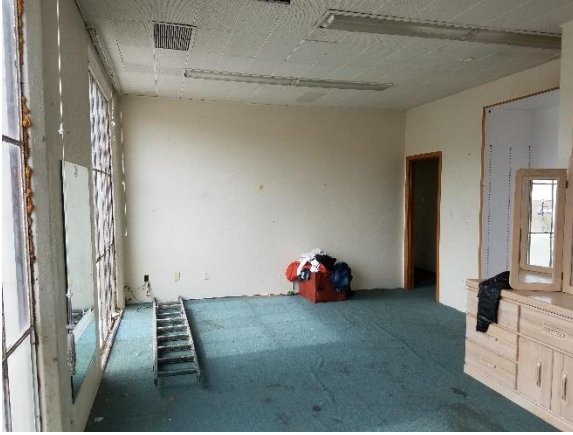
Figure 108: Typical lighting at second floor. Sept. 2021.

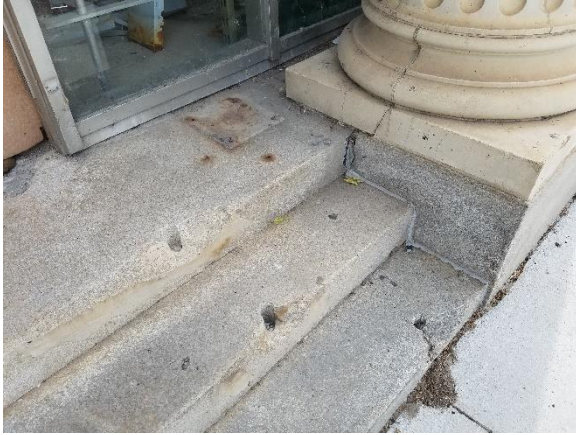
**Figure 109:** Three steps exist at south entry. Sept. 2021.

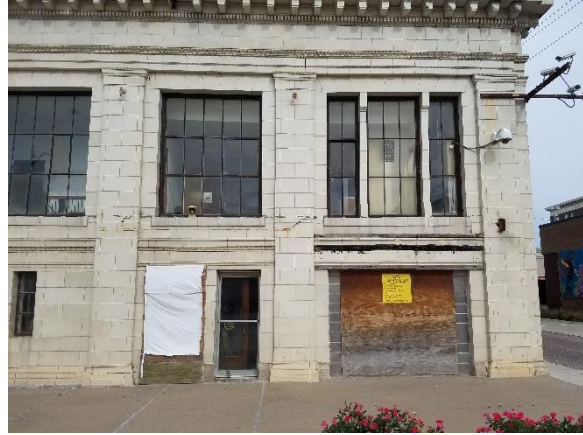
**Figure 110:** Small step at north end of east elevation. Sept. 2021.

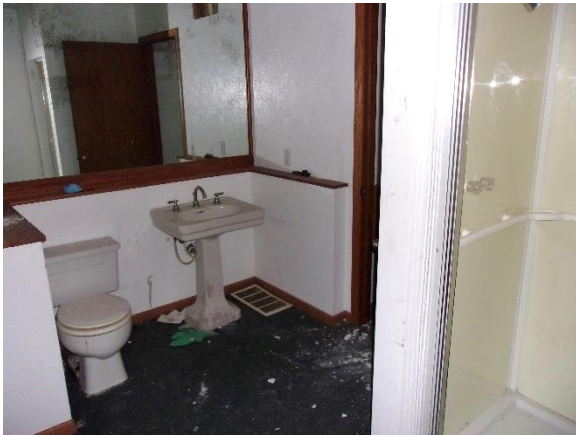
**Figure 111:** Non-accessible plumbing fixtures. Sept. 2021.

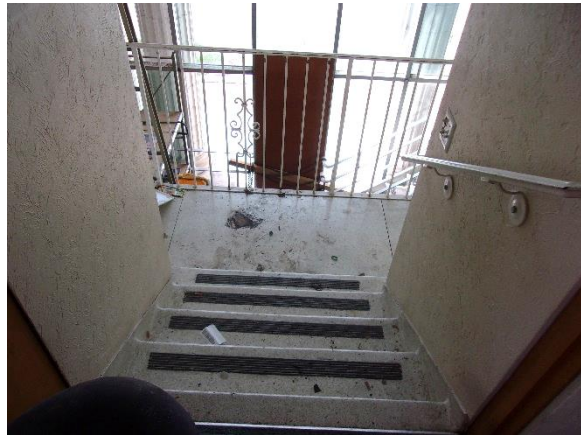
**Figure 112:** Steps from front entry staircase at second floor. Sept. 2021.

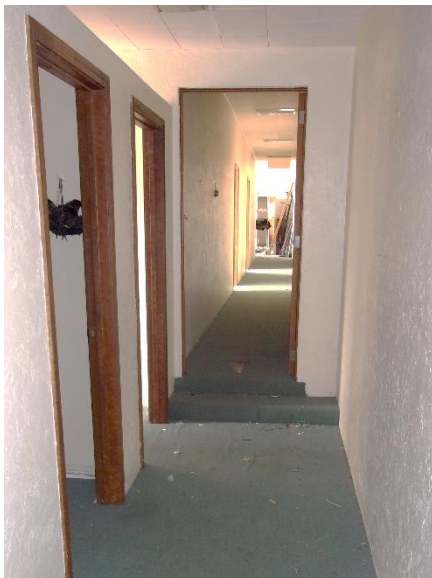
**Figure 113:** Two steps at second floor hallway. Sept. 2021.
