# FIRST NATIONAL BANK

131 Main Street | Ottumwa, Iowa

## Historic Structure Report

December 2021

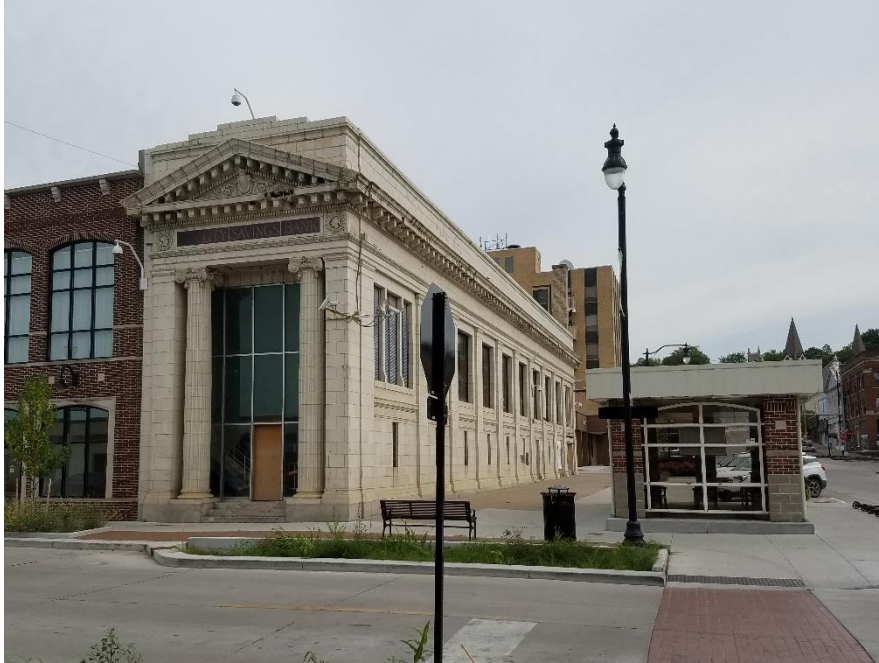
Figure 34: Overall view of the building. September 2021.

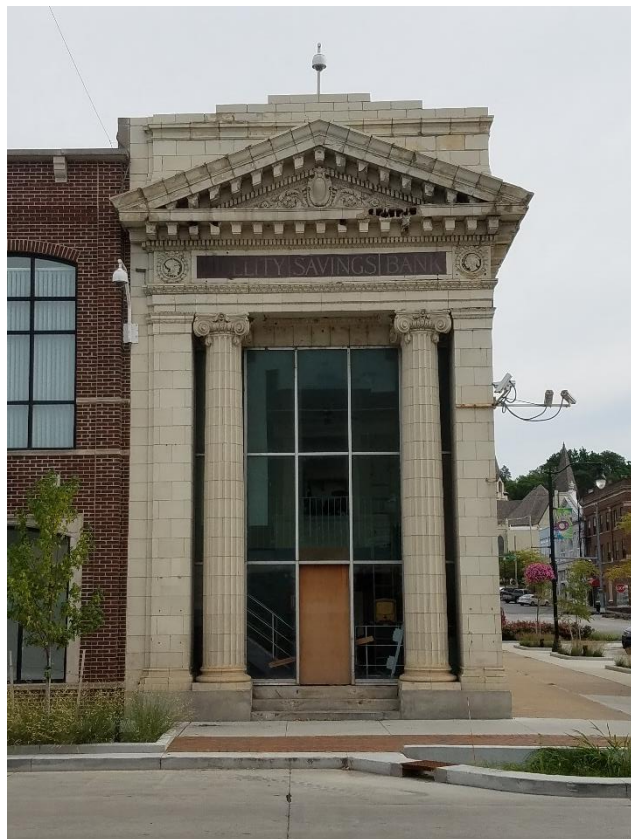
Figure 35: Overall south elevation. September 2021.

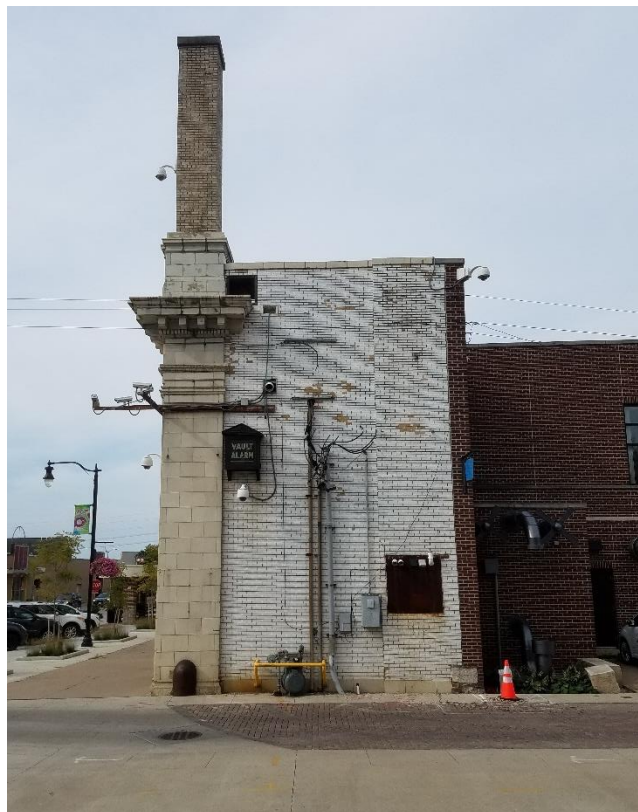
Figure 37: Overall north elevation. September 2021.

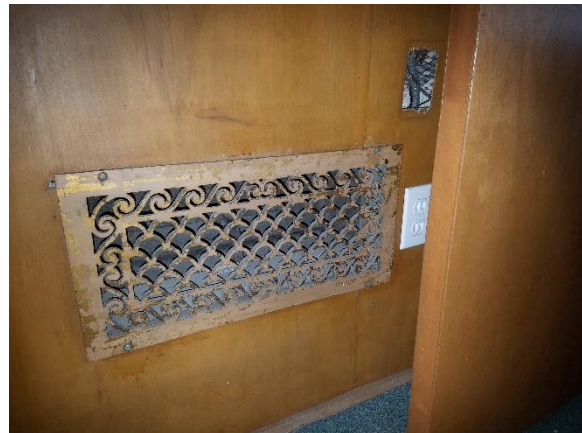
Plumbing fixtures are not original to the building but are more recent additions. Decorative registers are found on the first floor. It is unclear if these are original to the building. Finishes in the vaults are also a mix of original and more recent additions.

Figure 90: Decorative register at first floor. Sept. 2021.

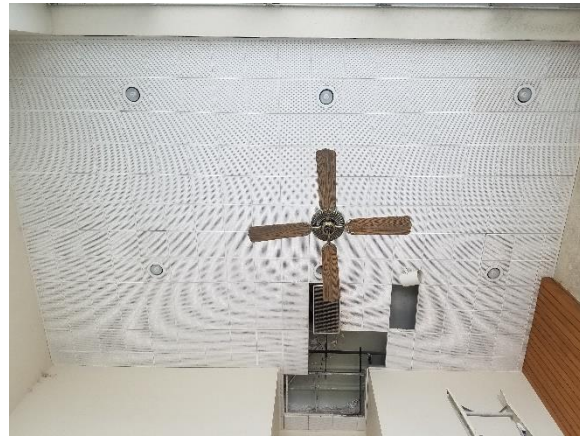
**Figure 107:** Canned lights at south entry. Sept. 2021.
